**OGV CLEAN FUEL REGULATION INVESTIGATION OF  
OPERATIONAL ISSUES PRELIMINARY FINDINGS**

**ARB CONTRACT No. 09-410**

**Robert K. Jackson  
Engineering Technology Department  
[rjackson@csum.edu](mailto:rjackson@csum.edu)**

**August 2011**

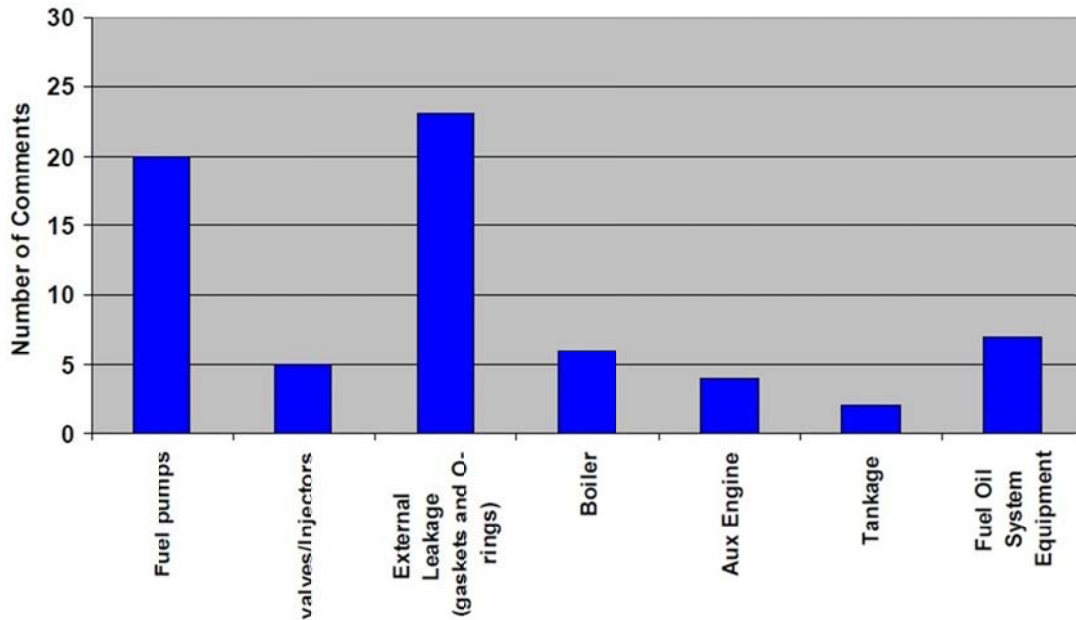
**Figure 2.2-2: OGV Survey Reported Equipment Problems**

The fuel switching operational problems reported in the ARB Survey were primarily noted as occurring after switching from heavy fuel oil to distillate (see Figure 2.2-2 below) and a higher number of problems were noted during maneuvering as compared to transiting. Equipment problems were noted across a variety of equipment with the highest number of problems focusing on equipment leaks and with fuel pumps as shown in Figure 2.2-2.

Excessive fuel leakage due to the low viscosity of distillate fuel can be a significant problem that can affect vessel operation (Figure 2.2-2). Excessive fuel leakage from fuel system gaskets and seals, circulating pump shaft seals, high-pressure fuel pumps, and fuel valves has been reported. Internal leakage through high-pressure fuel pumps and fuel valves can result in an excessive amount of fuel returning back to the fuel drain tank.

Excessive wear and scuffing on the high-pressure pump was reported. In two Survey reports the condition was sufficiently severe to cause seizure of the fuel pump plunger within the barrel. It is not known if the pump seizures were caused by improper fuel switching procedures or were due to low lubricity of the fuel. It is also not known if the pumps were operated with the fuel viscosity below the manufacturer's minimum limit of 2 cSt.

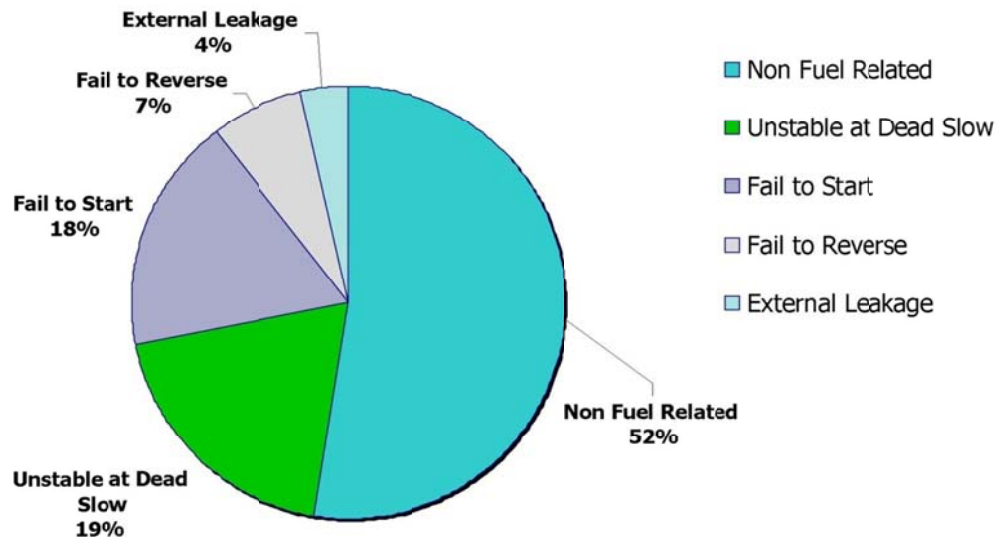
**Figure 2.3-2: Breakdown of LOP Incidents.**

It should be noted that over half of all the reported LOP incidents were not listed as fuel switching related, as seen in Figure 2.3-2 below. While there have been some vessels which have had difficulty operating on distillate fuel, LOP incidents are currently at pre-regulation levels. With about 10,000 vessel visits between July 1, 2009 and July 31, 2010 the vast majority are successfully operating on distillate fuel. However, continued operational difficulties remain a concern and this report provides an initial evaluation of the root causes of LOP incidents.

CMA Technical Staff reviewed the LOP incident reports that were denoted by the USCG as being fuel switching related and identified the primary operational issue that resulted in the LOP. As shown in Figure 2.3-2, the primary operational issues noted were: the main propulsion engine was unstable at low loads, the main engine failed to start, excessive fuel leakage, and failure to reverse. It is the opinion of CMA Technical Staff that the LOP incidents are primarily related to: 1) fuel viscosity management, 2) maintenance procedures, 3) crew training, and 4) fuel system equipment condition. Below, CMA Technical Staff discuss the four operational issues most commonly reported in the LOP Fuel Switching Related reports reviewed as part of this investigation.

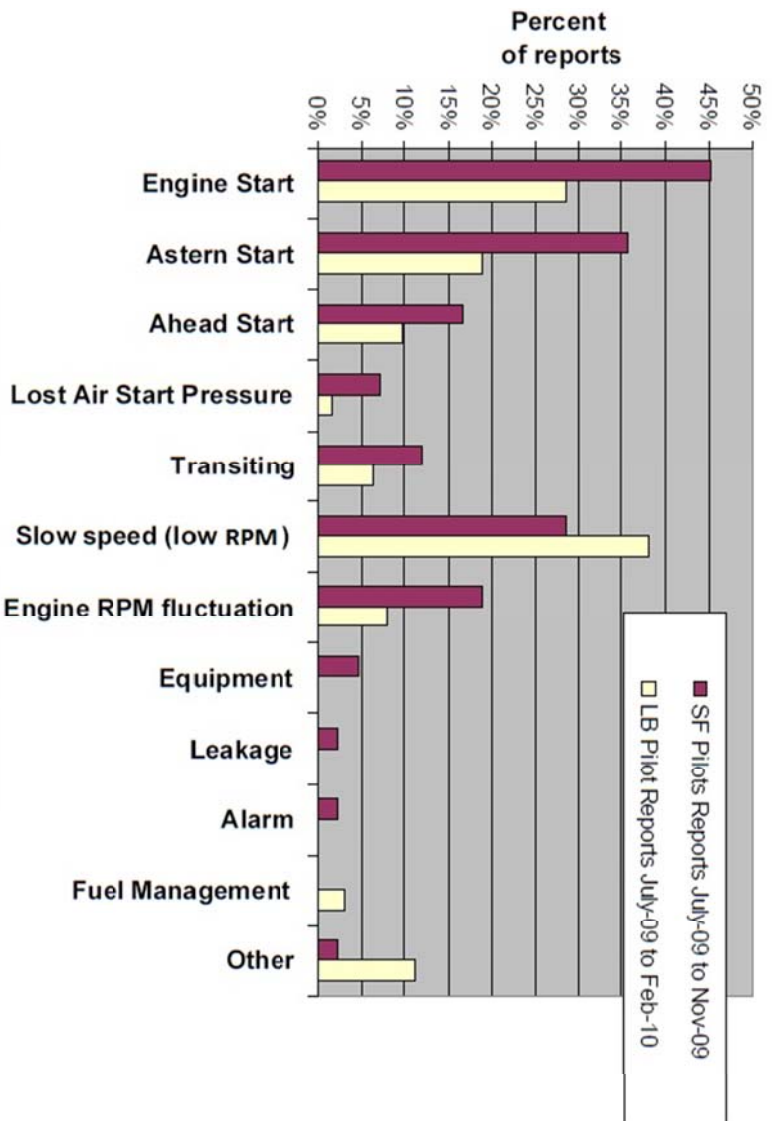
**Figure 2.4-1: Breakdown of OGV Incidents Reported by SF Bar & LB Pilots**

As is shown, the vast majority of the operational incidents reported instability of the engine at low RPM (Dead Slow) or failure to start while running on distillate fuel. In addition, some vessels have reported difficulty starting the main engine in the astern direction while the vessel is moving through the water above a certain speed. The CMA Technical Staff believes the root cause for all three of these problems was poor combustion at low loads caused by low injection pressures and/or improper injection timing.

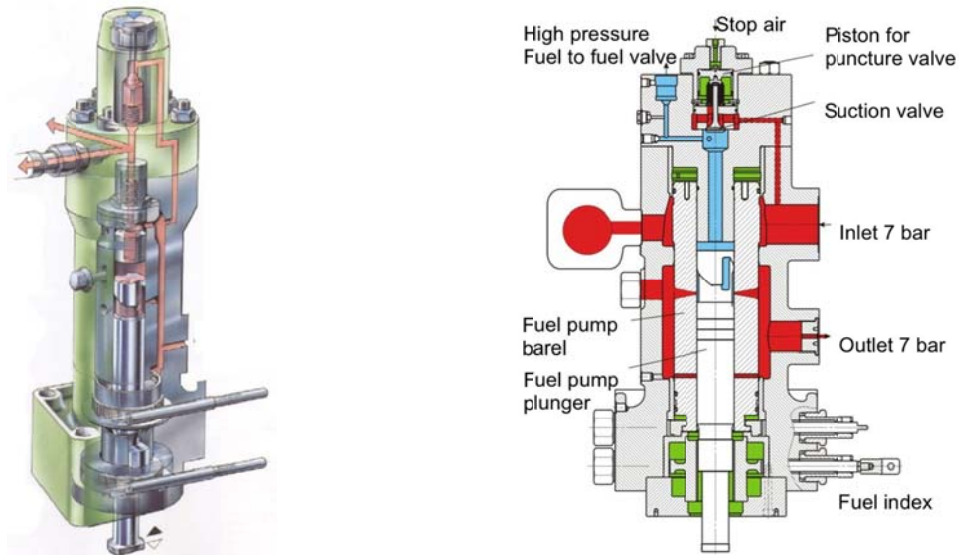
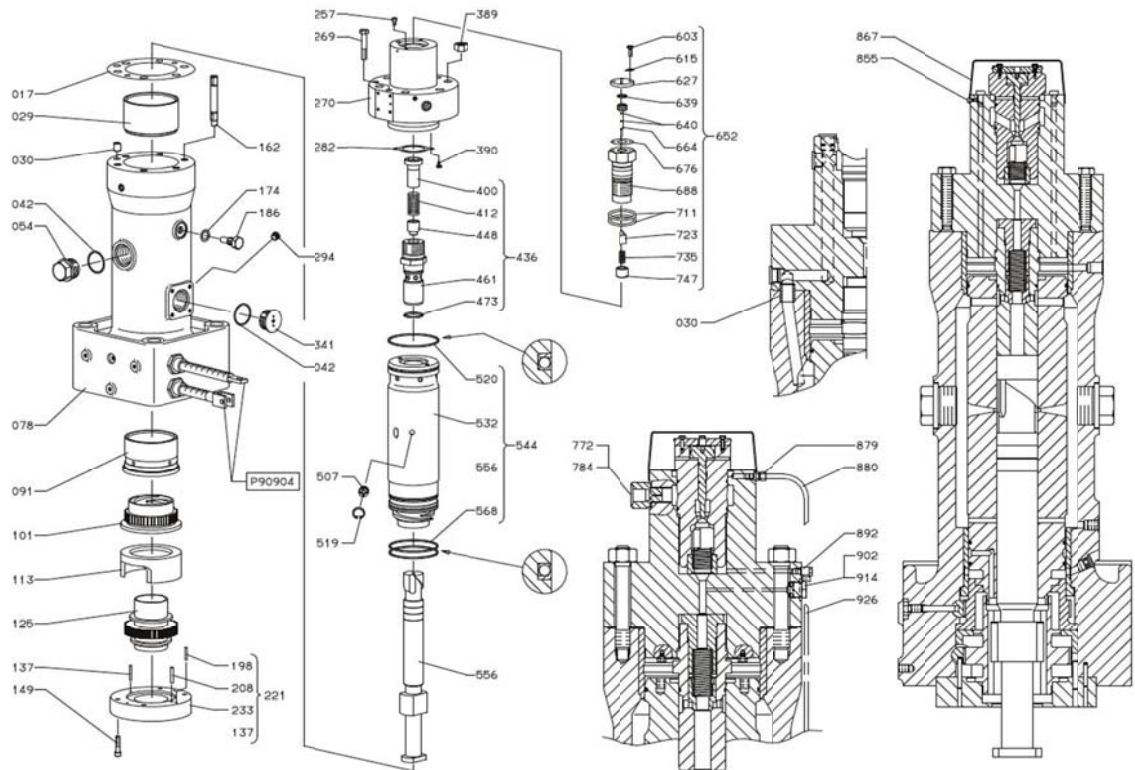
The high pressure fuel pump system for a typical main engine is shown schematically in Figure 3.3-1 and as an assembly drawing is shown in Figure 3.3-2. This component has been associated with issues concerning leakage past the suction valve and internal O-rings. High pressure fuel pump leakage can occur due to, 1) worn barrel and plunger (piece 556 & 532), 2) leaking puncture valve slide (piece 723) or valve housing “O-ring” seals (piece 711), or 3) Leaking suction valve slide (piece 448) or seal (piece 473.)

The barrel and plunger are manufactured to very precise tolerances to minimize fuel leakage. A small amount of leakage is required as the fuel is utilized to lubricate these moving metallic parts. Over time, as the pump plunger and barrel become worn fluid leakage will increase. Using fuel with lower viscosity will increase the leakage volume even further. If the leakage becomes excessive, it will reduce the pump discharge pressure resulting in a reduced volume of fuel going to the engine.

Problems with the fuel pump have been correlated with excessive internal leakage between the high-pressure pump plunger and barrel. This problem was identified as a likely root cause for some of the LOP incidents. For fuels with lower viscosity, more leakage will occur thereby decreasing fuel injection pressures.

The fuel pump index is dependent on the amount of pump wear and the viscosity of the fuel oil. Worn fuel pumps and leaking suction valves will show up as an increased fuel index. The manufacturer recommends overhauling the pumps when the index has increased 10% above the fuel index for a new pump.
