**OGV CLEAN FUEL REGULATION INVESTIGATION OF  
OPERATIONAL ISSUES PRELIMINARY FINDINGS**

**ARB CONTRACT No. 09-410**

**Robert K. Jackson  
Engineering Technology Department  
[rjackson@csum.edu](mailto:rjackson@csum.edu)**

**August 2011**

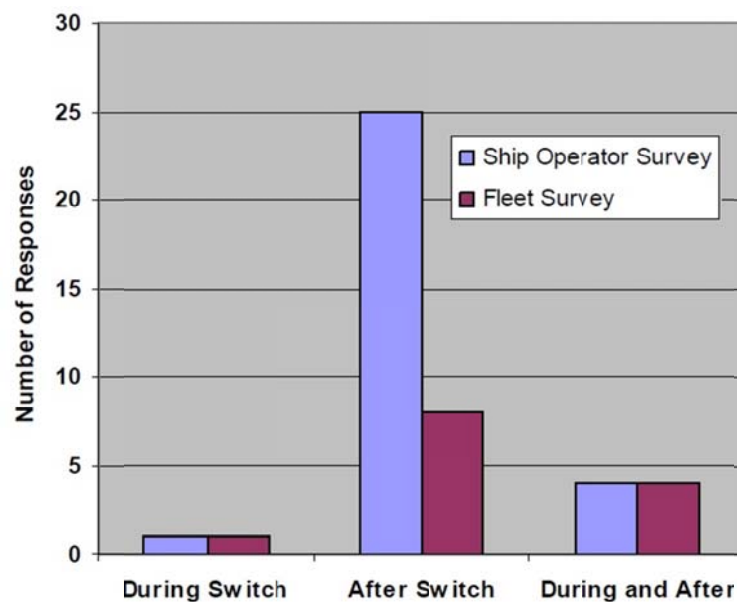
**Figure 2.2-3: OGV Survey Timing of Problems Due to Fuel Switching**

Figure 2.2-3 illustrates the responses to an OGV Survey question “If you had problems, did the problems occur during fuel switching, after fuel switching or both?” Vessel operators reported that more difficulties occurred after fuel switching than the time period during which the fuel switching was taking place.

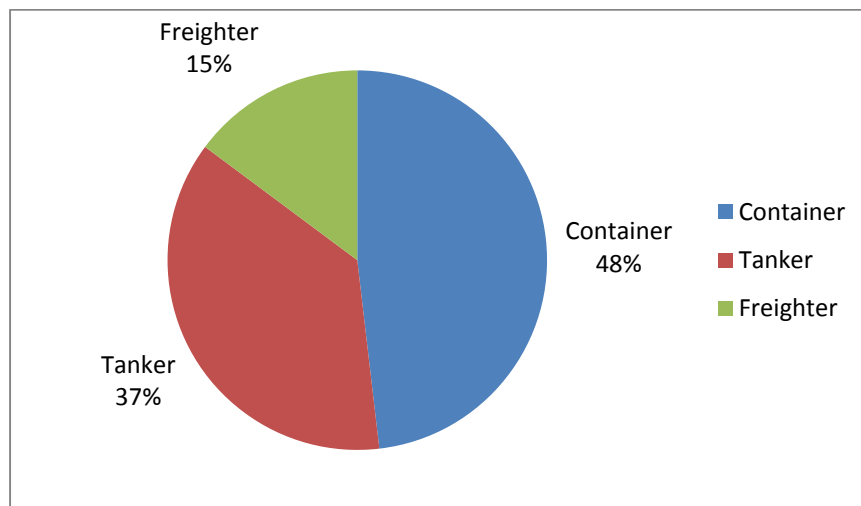
**Figure 2.3-3: Vessel Types Involved in Fuel Switching Related LOP Incidents from 7/1/09 through 9/2/10**

To date all of the vessels reporting a loss of propulsion have utilized the 2-stroke cycle slow-speed crosshead type diesel engine for propulsion. Figure 2.3-3 illustrates the different types of vessels which encountered Fuel Switching Related LOP incidents.

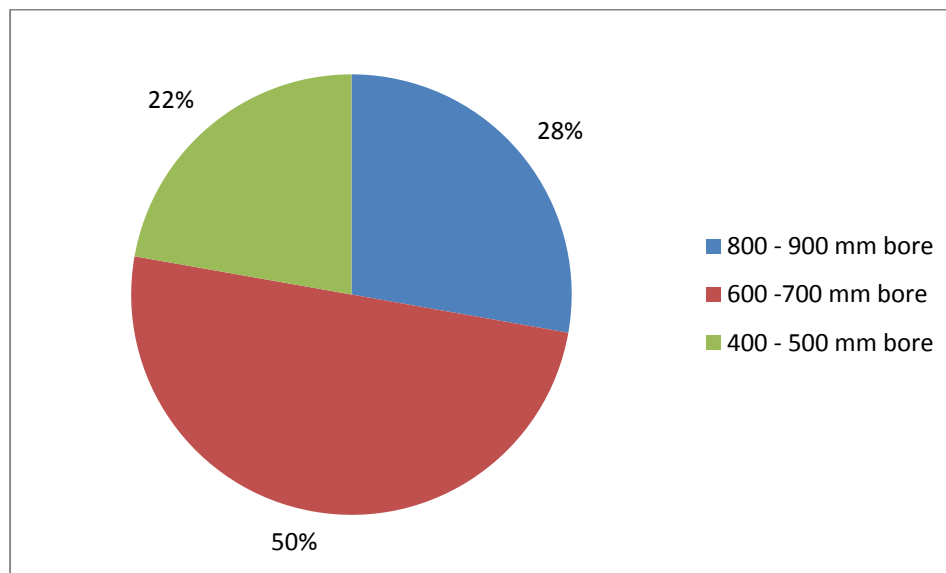
**Figure 2.3-5: Fuel Switching Related LOPs Referenced by Cylinder Bore Size**

Figure 2.3-4 is a breakdown of all LOP incidents regardless of cause. A comparison of the engine bore size for fuel switching related LOP incidents is given in Figure 2.3-5. While engines with bore sizes between 600 & 700 mm have the highest percentage of incidents, this may be due to the popularity of this engine size.

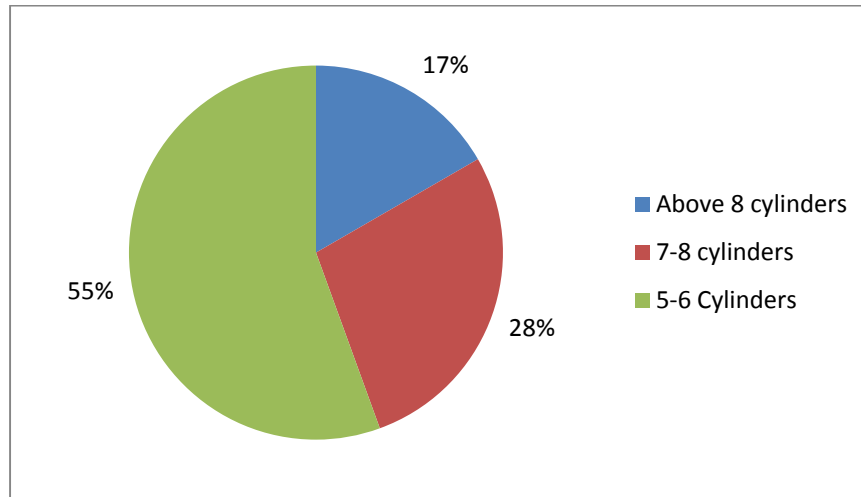
**Figure 2.3-6: Fuel Switching Related LOPs Referenced by Number of Engine Cylinders**

The fact that engines with fewer than seven cylinders have the largest percentage of fuel switching related LOP's as shown in Figure 2.3-6 may be more than purely statistical. The more cylinders that an engine has the less it would be affected by poor combustion in one of those cylinders.

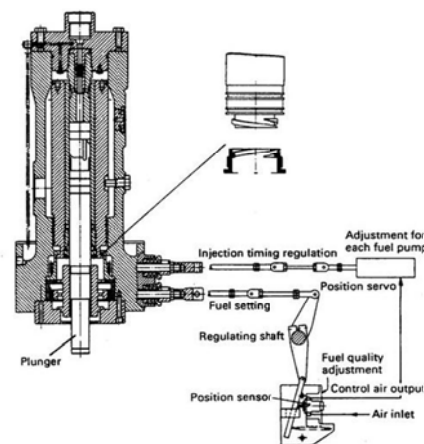
**Figure 3.4-1: Super VIT System**

Figure 3.4-1 depicts a common control arrangement used by MAN B&W on the slow-speed diesel engines. In this arrangement the pump barrel can be mechanically raised or lowered to advance or retard injection timing. The pump barrel has a threaded lower end which fits into the internal threads of the timing guide. The timing guide has a gear rim which meshes with a toothed rack that is linked to a servo-air cylinder. The position of the upper toothed rack determines the vertical position of the barrel relative to the plunger.

The VIT system must be checked regularly to insure that the system is moving freely and is operating in the manner prescribed by the engine manufacturer.
